NATURAL EXPOSURE OF SELECTED GRAPHITE/EPOXY  
COMPOSITE MATERIAL SYSTEMS

R. E. TRABOCCO  
Aircraft and Crew Systems Technology Directorate  
NAVAL AIR DEVELOPMENT CENTER  
Warminster, Pennsylvania 18974

31 JULY 1980

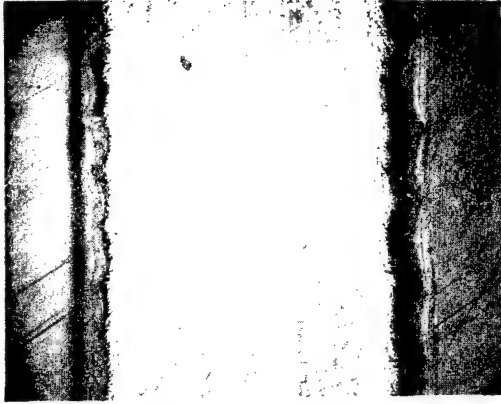
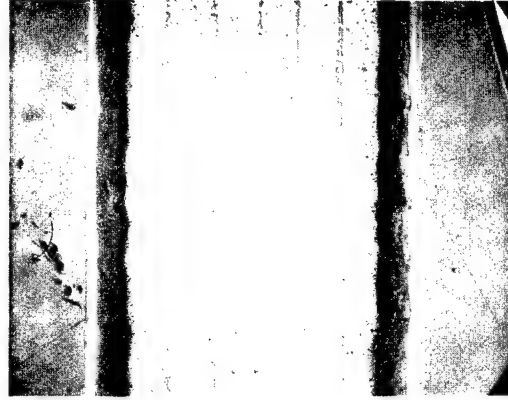
FIGURE 39 A COMPARISON OF COATED EXPOSED AND UNEXPOSED LAMINATE MICROSTRUCTURES (35X)

The microstructures of coated samples are typical of those shown in Figures 38 and 39. Little or no effect of natural weathering is evident on these microstructures.
